**CHASE MILL DAM  
ME-00335**

**PHASE I INSPECTION REPORT  
NATIONAL DAM INSPECTION PROGRAM**

**MAY 1979**

November 28, 1978

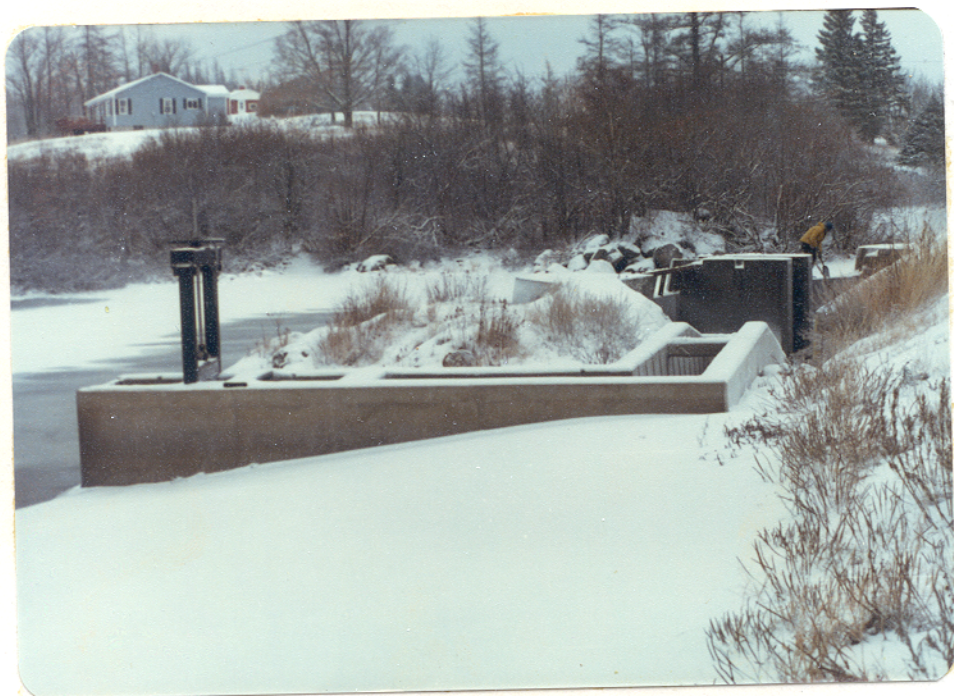
1

- c. Appurtenant Structures. The concrete fishway, located at the north end of the dam, appears to be in good condition. The embankment areas adjacent to the fishway are low and appear to be overtopped during high flow periods. However, there appeared to be no serious erosion.

FISHWAY

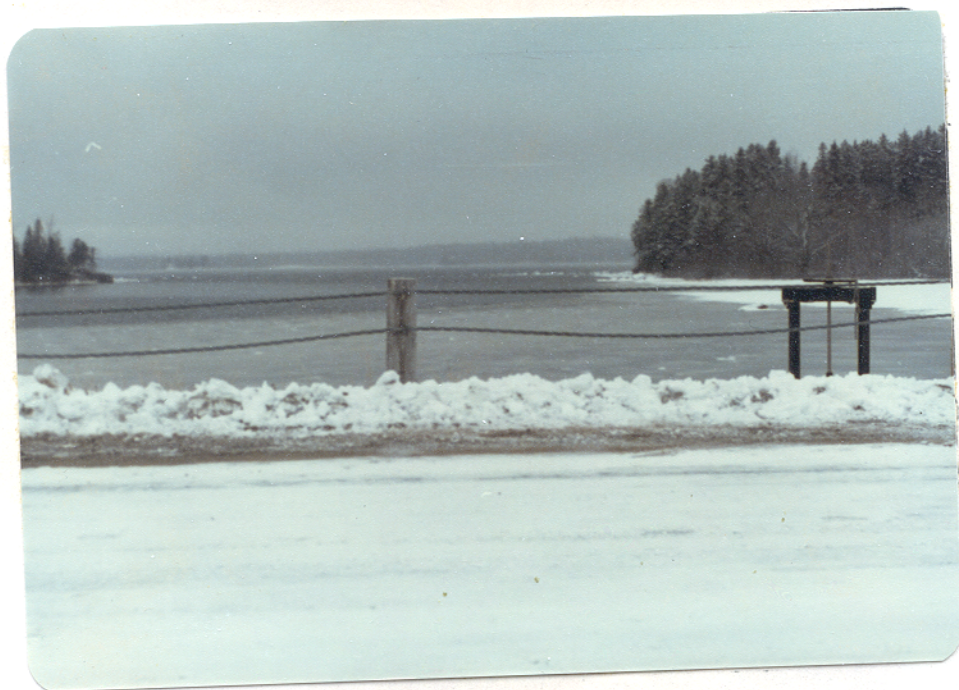
2

- d. Reservoir Area. Gardner Lake, which is about 5250 acres, forms the reservoir for Chase Mill Dam. The lake has a forested shoreline, as shown in Photograph 2. There are several cottages and year round residences on the lake. The potential for slope failure above the dam appears minimal.

VIEW UPSTREAM

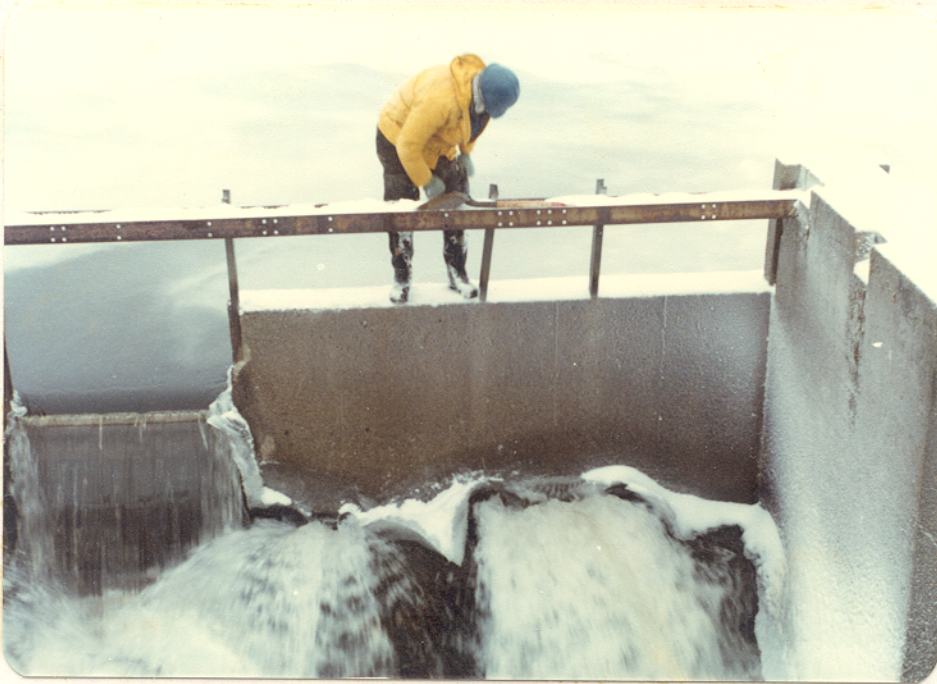
- (a) Major leakage is occurring through the joint between the spillway weir and the foundation sill. See Photographs 3 and 4. This leakage is apparently coming through the joint directly from the upstream face of the dam.

No leakage was observed at the junction between concrete bedrock in the north portion of the dam, or along the toe of the downstream face. However, a large amount of leakage is occurring through the joint between the dam foundation sill and the spillway wall. It appears that this joint is open and water is piping directly from the upstream face through to the downstream face. This leakage was estimated to be in excess of 2 cfs west of the center piers and in excess of 1/2 cfs in the easterly portion of the dam.

Vertical joints in the dam appear to be in good condition, however, the horizontal joints between the concrete foundation sill and the vertical spillway face appear to be open. A large amount of leakage is occurring through this joint. The joint between the southerly wall of the stop log outlet section #1 and the spillway section #1 also is leaking, however, the joint appears to be relatively tight.

LEAKAGE DOWNSTREAM FACE

1. Seal the joint at the junction of the spillway weir and the sill and the spillway weir and abutment to curtail leakage.
2. Fill the low portion of the embankment adjacent to the fishway to a grade at least two feet above the elevation of the northerly abutment and provide an erosion resistant surface.
3. Provide around-the-clock surveillance during periods of anticipated high runoff.
4. Have inspections of the dam made by qualified engineers once every 2 years.

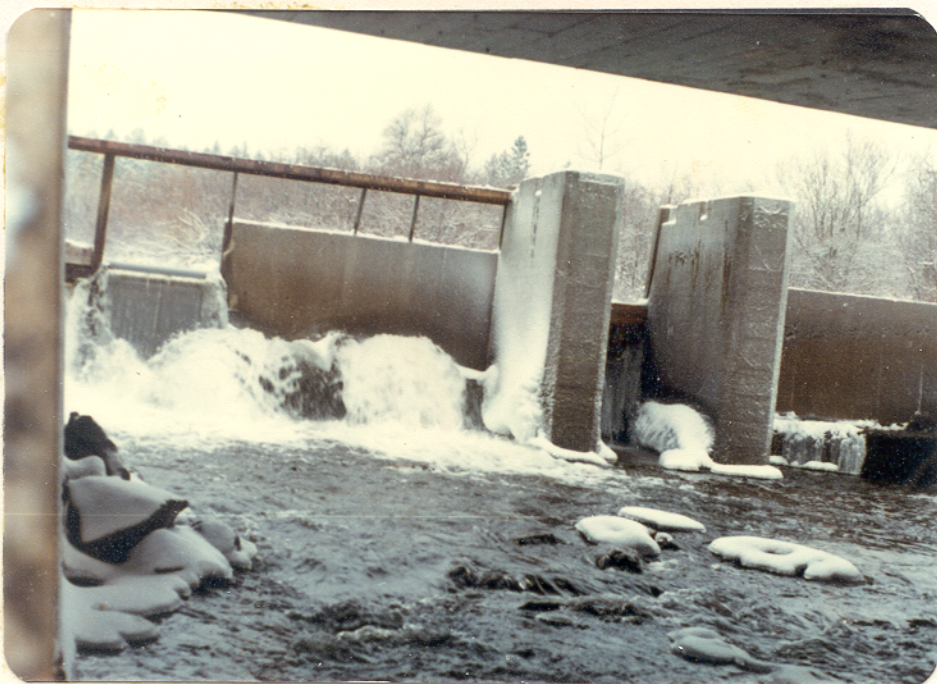
4

DOWNSTREAM FACE

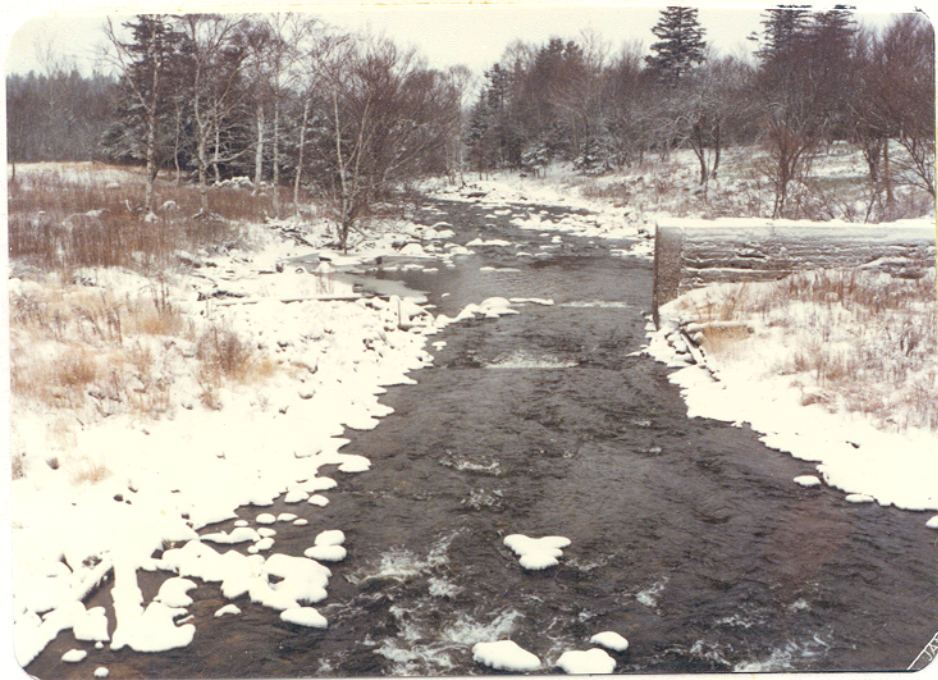
5

The approach channel was found to be clear and unobstructed. The outlet channel is somewhat restricted by a bridge located immediately downstream from the dam. No debris or major obstructions were observed in the outlet channel.

DOWNSTREAM CHANNEL
